SITE INSPECTION REPORT

SITE: Pacific Fruit Express
ADDRESS: 2501 E. Fairland Stravenue, Tucson, AZ 85713
EPA ID #: AZD045804325
STATE ID #: 235

NAME: Judy Heywood, Hydrologist
DATE: March 7, 1989

Arizona Department of Environmental Quality
Office of Water Quality
Groundwater Hydrology Section
Superfund Hydrology Unit

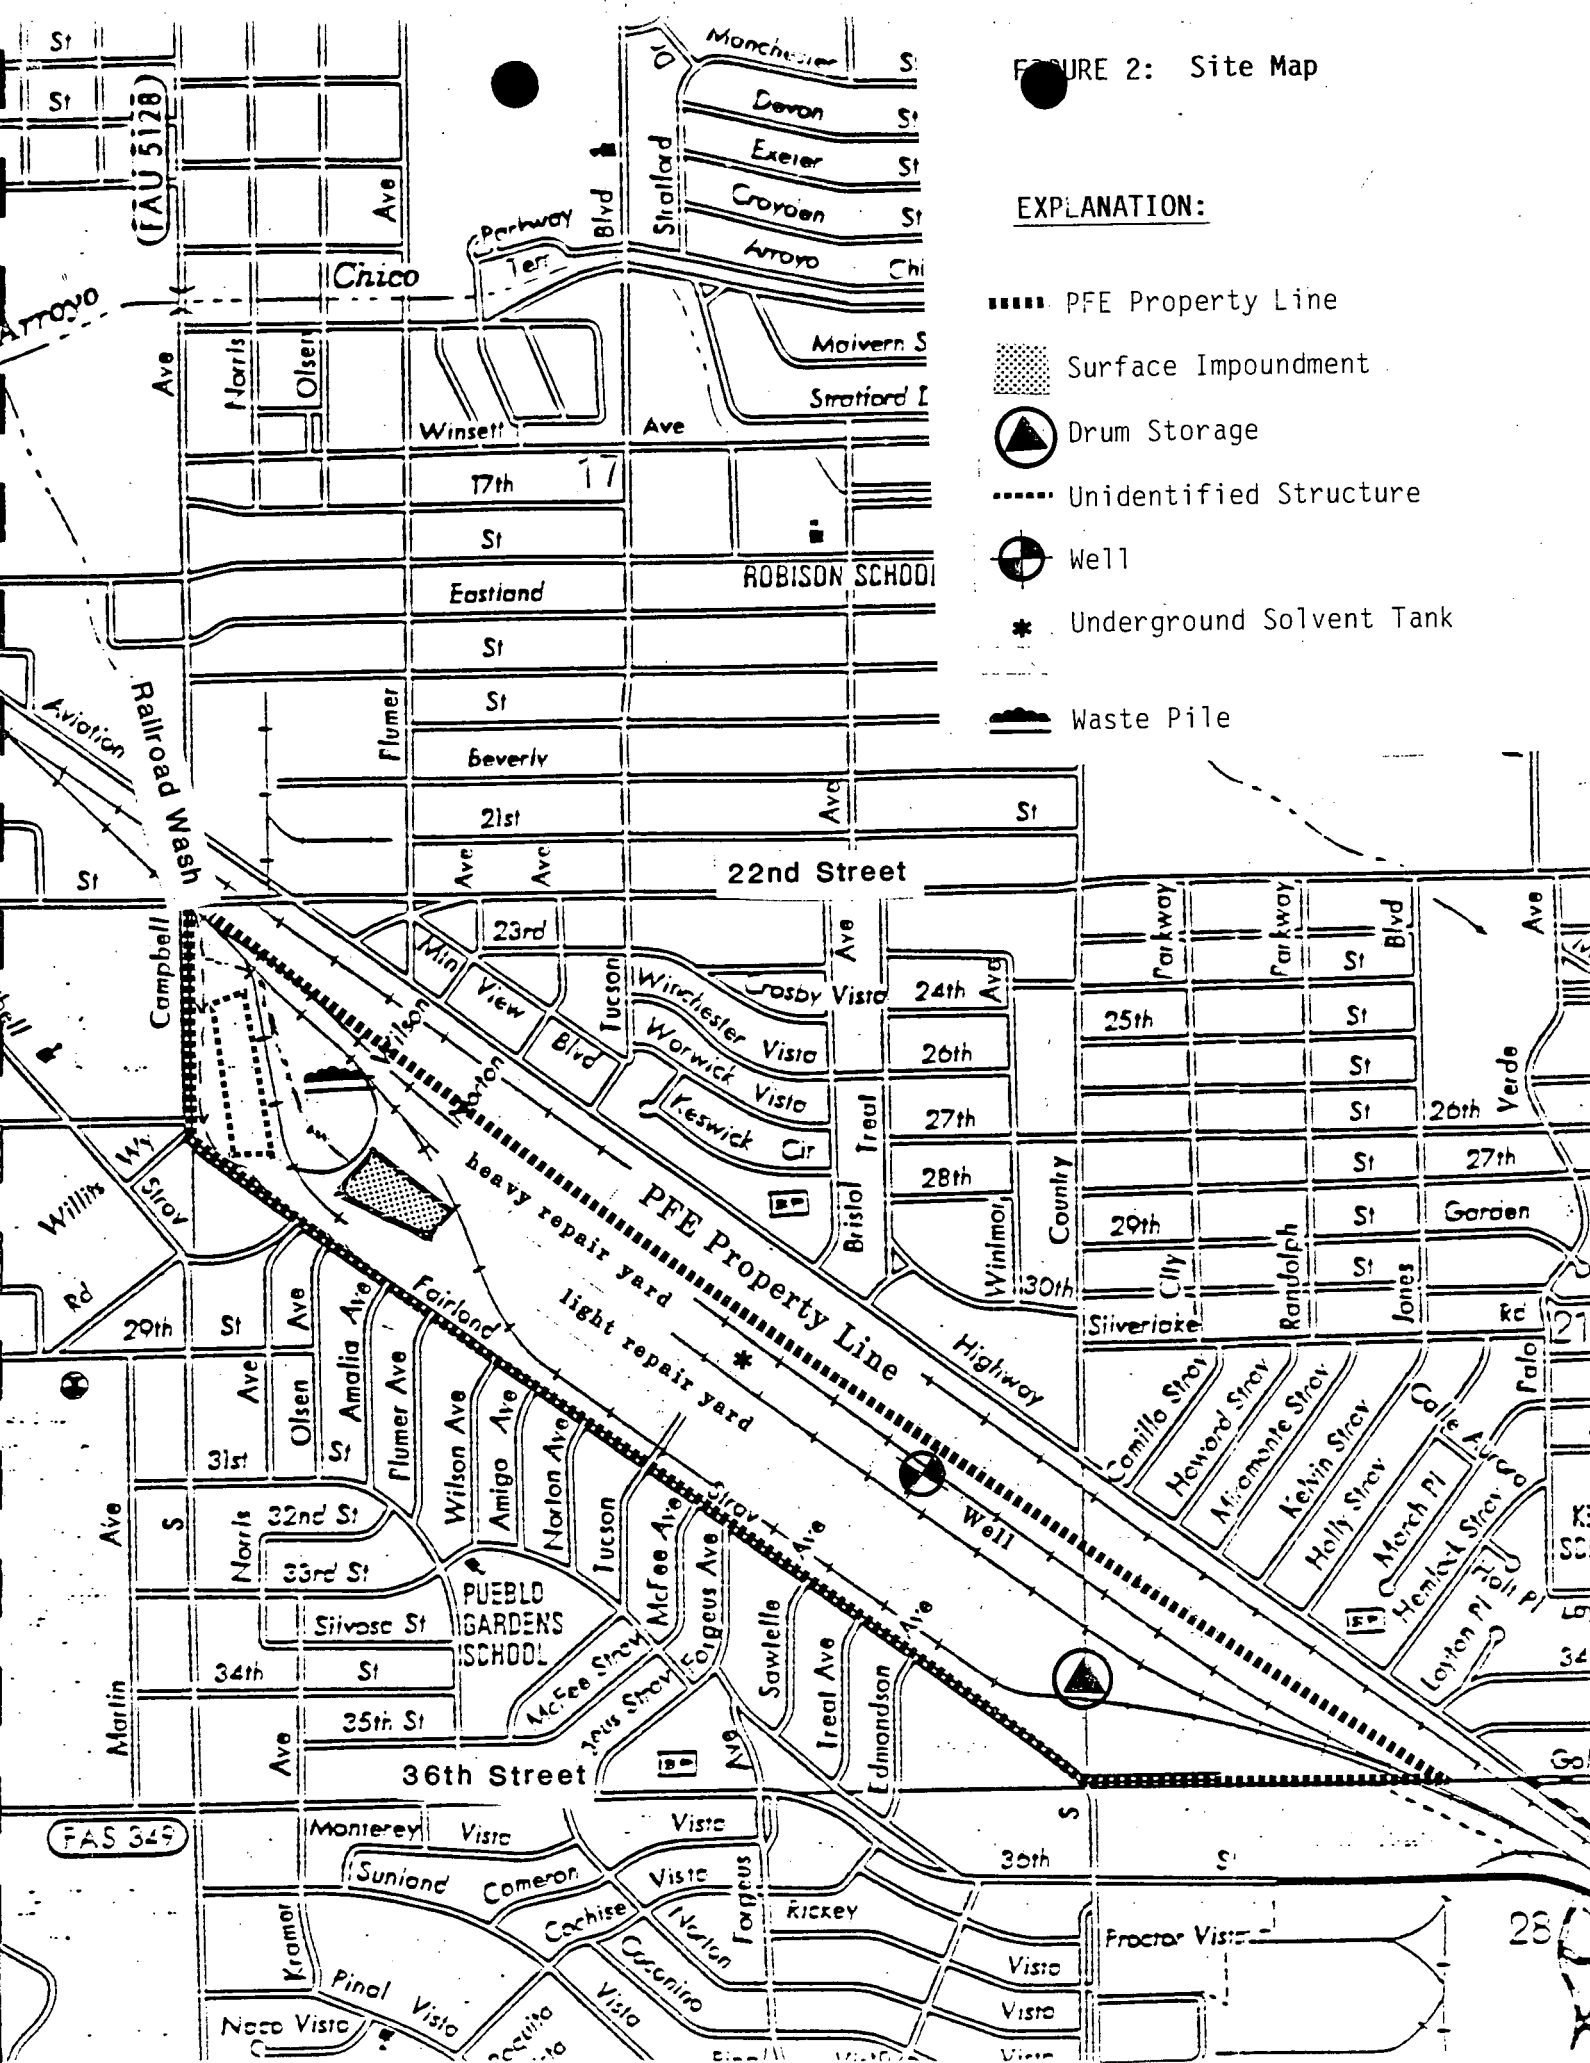
FIGURE 2: Site Map

The PFE occupies 110 acres at this location. The facility includes approximately 30 structures and 15 railroad side tracks throughout the yard. In addition, the facility has an oil skimmer and surface impoundment on site. The facility has doubled in size since 1907, due to additional railroad tracks. PFE had one other facility located in the Tucson area, an ice plant. The ice plant was located at Euclid and Broadway Roads from 1907 to 1968, when it burned down. (2)

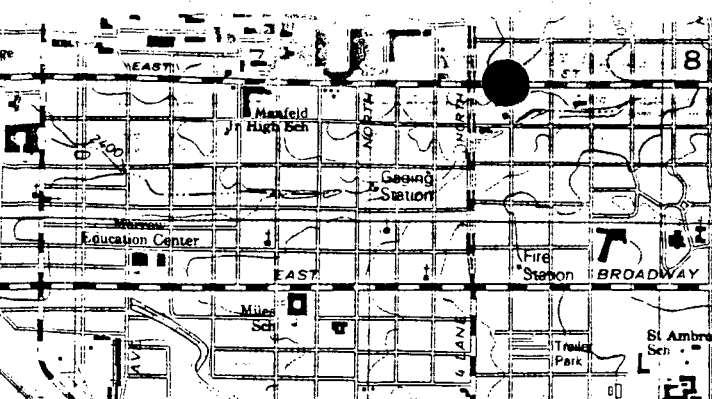
FIGURE 4: Groundwater sample location - wells sampled

(D-14-14)20bab, COT B-78: This city of Tucson public supply well is located 0.4 mile north of the PFE facility and potentially downgradient. The well was drilled to a depth of 500 feet and screened from 160 to 500 feet below land surface. The depth to water was measured at 196.4 feet below land surface on 1/2/86. The well is equipped with an electric line shaft turbine pump. The discharge, measured with an in-line meter, was 460 gpm at the sampling on 9/15/88. The sample was obtained from a faucet on the discharge pipe. The well was pumping upon arrival at the site and for at least the 24 hours prior to sampling.

(D-14-14)20aca, COT B-19: This City of Tucson public supply well is located 0.3 mile north and downgradient from the PFE facility. This is the closest off-site downgradient well and was drilled to a depth of 545 feet. This well is equipped with an electric line-shaft turbine pump. A discharge of 250 gpm was measured with an in-line meter at the time of sampling 9/15/88. The water level in this well was measured at 208.7 feet on 1/2/86. The sample was obtained from a faucet on the discharge pipe. The well was pumped 20 minutes prior to sampling.

(D-14-14)18dcb, Kalil: This well is located one mile northwest of PFE and is drilled to a depth of 500 feet. The screened interval is set at 220 to 498 feet below land surface. This well is potentially located downgradient from PFE under regional flow conditions. This well is equipped with an electric submersible pump. The water sample was obtained from a tap on the discharge pipe. The well was pumping upon arrival at the site and was cycling on and off for at least the 24 hour period prior to sample collection.

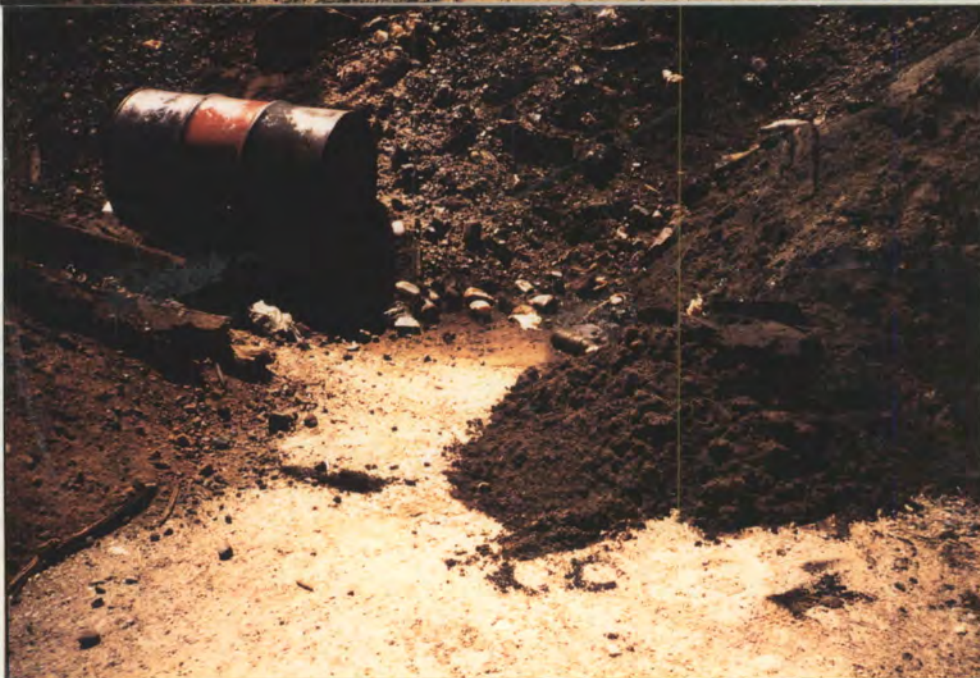
6.

5. A waste pile of stained soil, unmarked drums, and debris is located in the northwest section of this facility. This waste pile, shown on Figure 5 and Photos # 6, 18, and 21, is approximately 75 feet in length, 20 feet in width, and 12 feet in height.

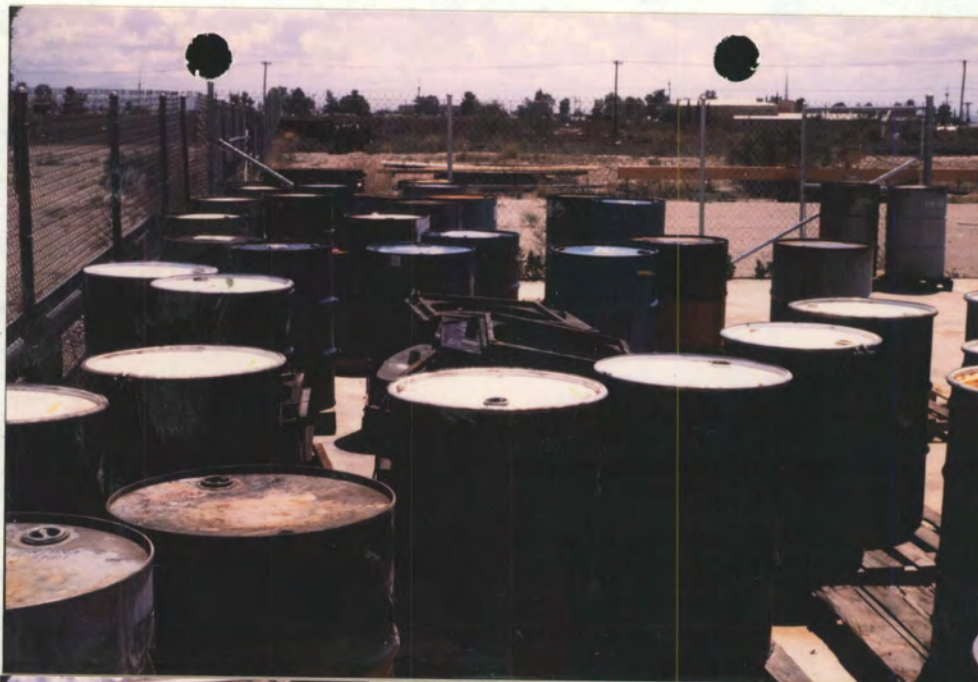
7. Waste Drum storage area
8. Waste Drum storage in work area
9. Oil and Fuel drums (note stained soil)
10. Railyard
11. Typical intake drain for impoundment
12. Typical intake drain for impoundment

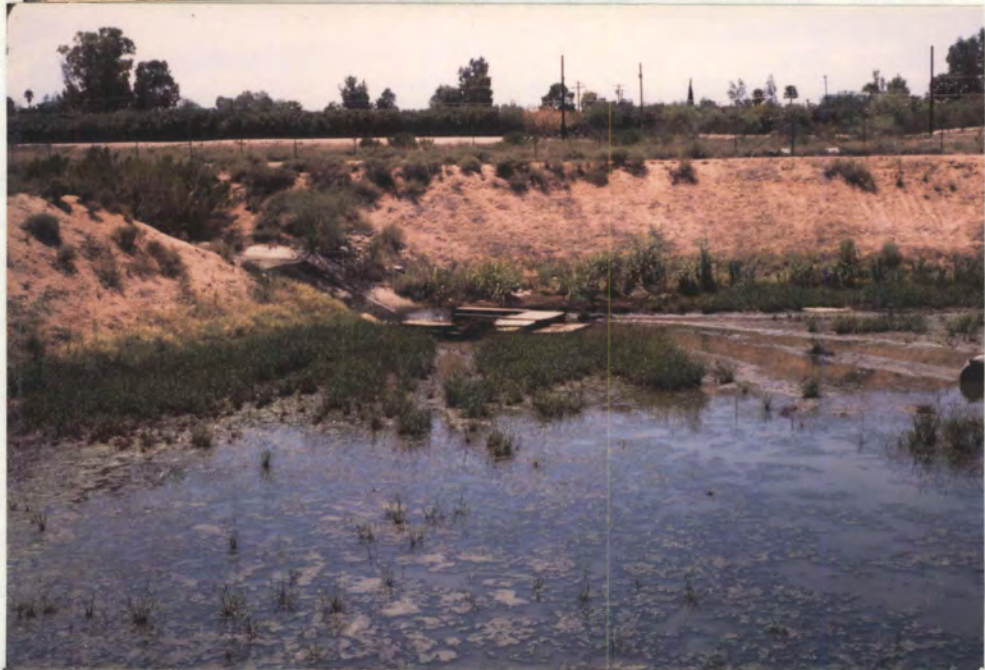
13. Diversion gate
14. Belt skimmer
15. Surface impoundment inlet from diversion gate
16. Edge of impoundment (note drum)
17. Surface impoundment, southern end (note stained soil)
18. Surface impoundment from south looking north - arrow indicates waste pile
19. Surface impoundment outlet to ditch connecting to Railroad Wash
20. Railroad Wash - looking north
21. Waste pile east of Railroad Wash.

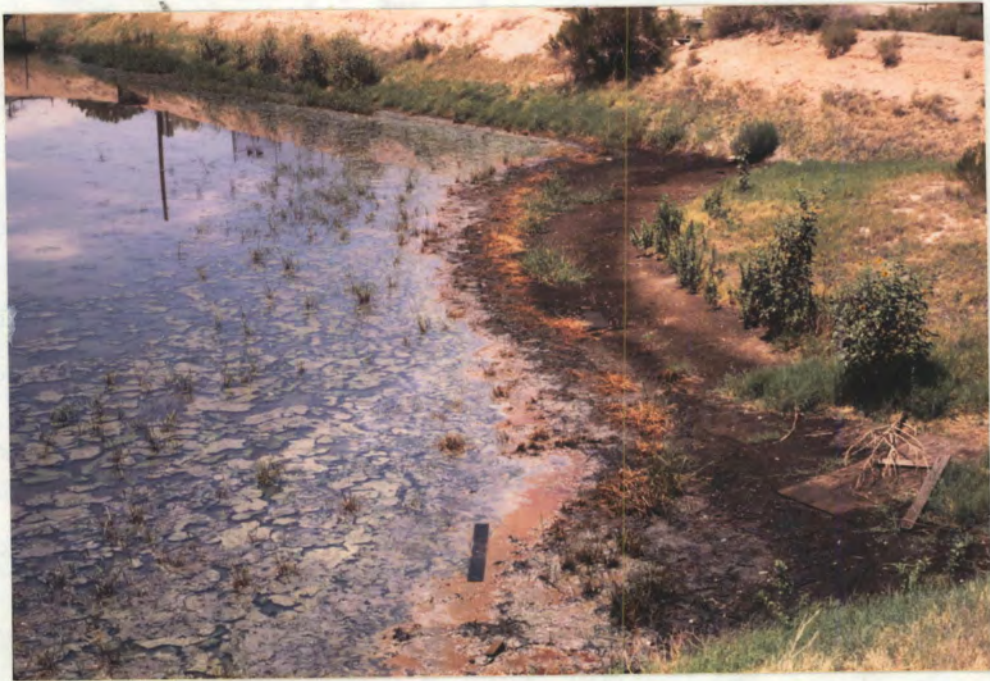
17.

Some of the natural vegetation in and around the surface impoundment appears to be stressed. See Photo Documentation, Appendix C. In addition, several areas on site have stained soil and/or pavement stains.⁽⁶⁾
